Forensic engineering methodology to assess the Maintenance, Repair and Overhaul (MRO) procedures for Gas Generator Turbine Cooling Plates

Abstract. Investigation was carried out on a set of cooling plates obtained from a gas generator turbine (GGT). The need for the assessment of the durability and remaining operational life of the gas generator turbine component was identified, following a recommendation by the manufacturer for the early replacement of the cooling plates. The current study applied a forensic engineering and failure analysis methodology to assess the Maintenance, Repair and Overhaul (MRO) procedures of high reliability components. From the results of the current investigation it was finally deduced that, in spite the fact that the plates seemed to be macroscopically in good condition, certain metallurgical observations sustained the claim for early component replacement.

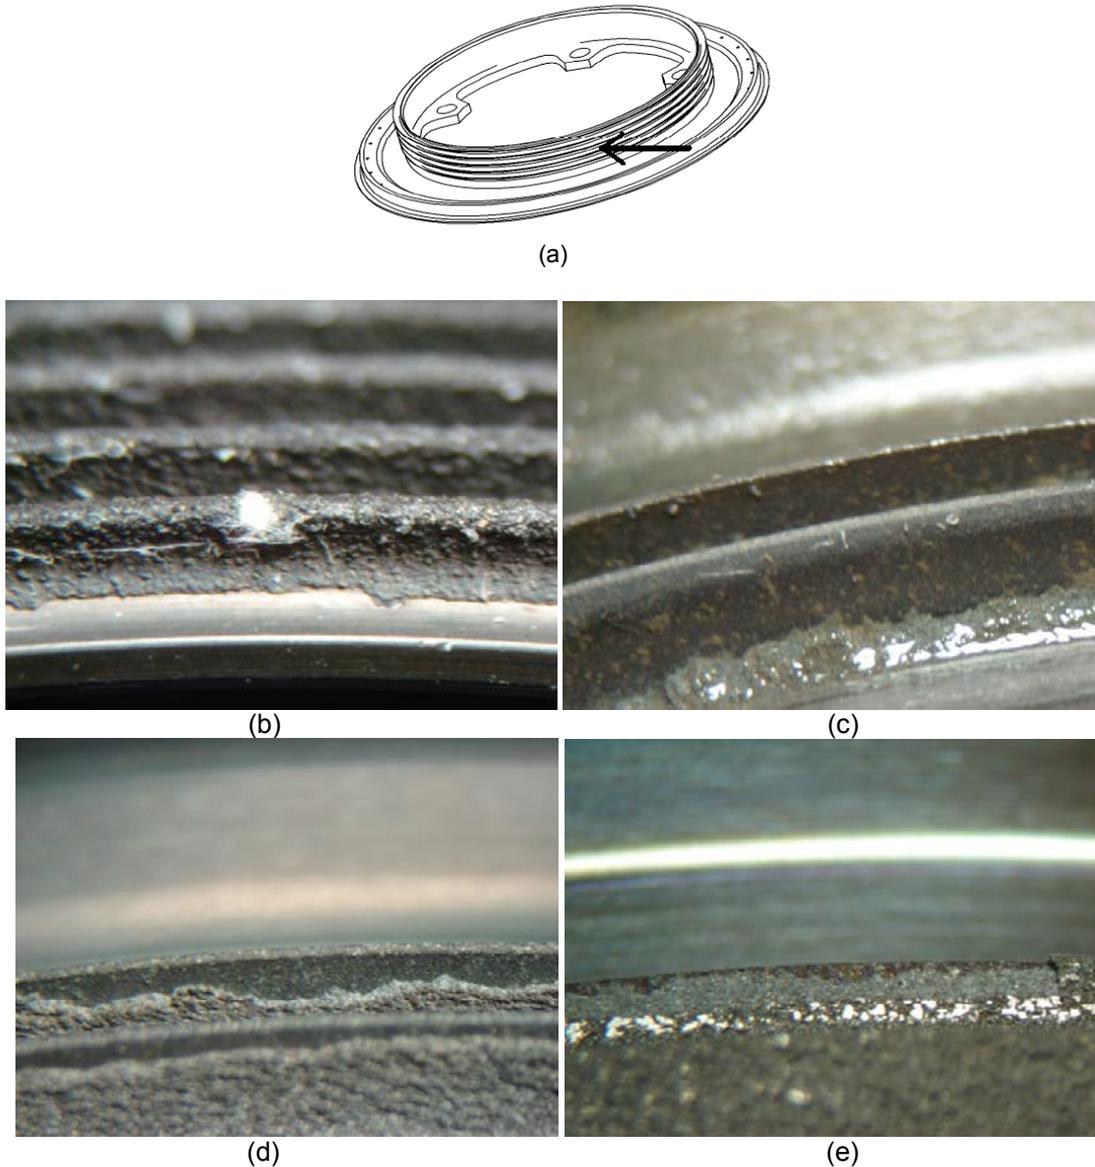
figure 3). After cleaning of the specimens it was revealed that they were deposited with a protective coating. As depicted in figure 4, in four out of the eight plates, the protective coating was worn (lost) or fractured exposing the substrate of the plate to the surrounding combustion gasses.

FIGURE 4. (a) Observation of the thread. (b)-(d) Existence of worn coating (lost) in three different plates. (e) In one plate the coating has been fractured.

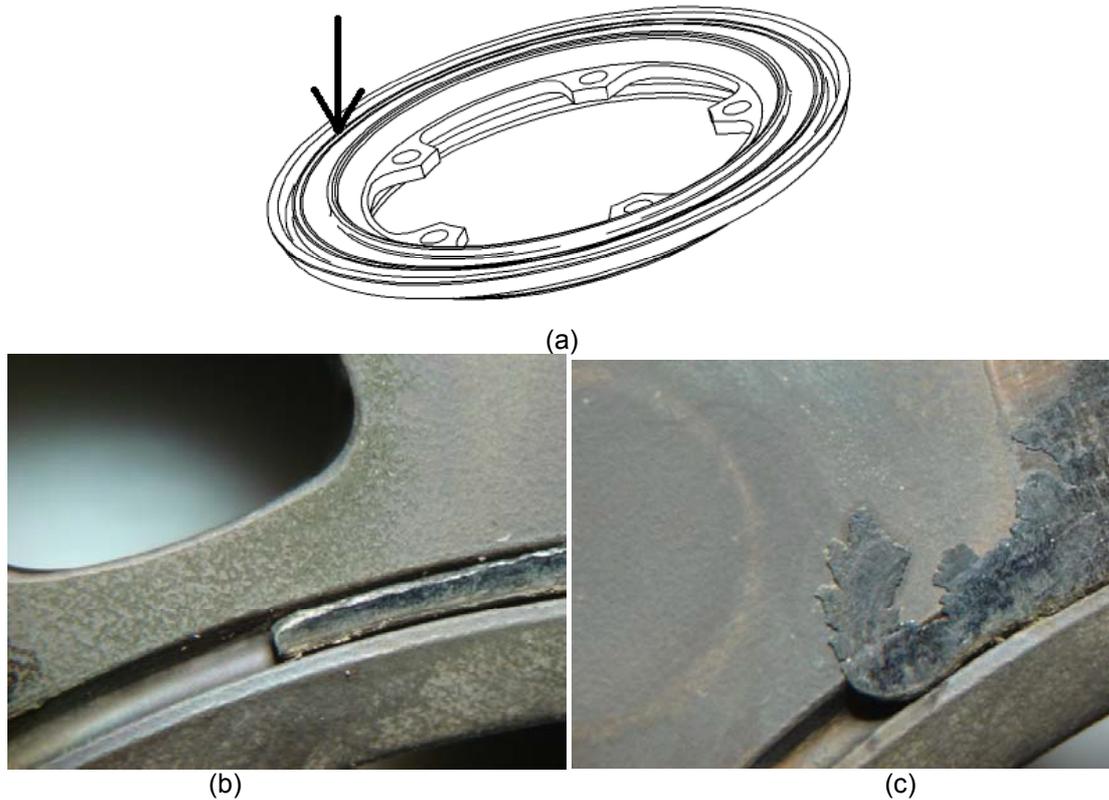
Fracture and local plastic deformation of a structural element contained in one cooling plate was also identified as depicted in figure 5. Further detailed observation of the surface of the eight plates did not reveal any cracked areas. The latter was also confirmed by the non-destructive fluorescent penetrant inspection.

FIGURE 5. (a) Observation of the flange of one plate. (b) Fractured structural element. (c) Plastically deformed structural element.

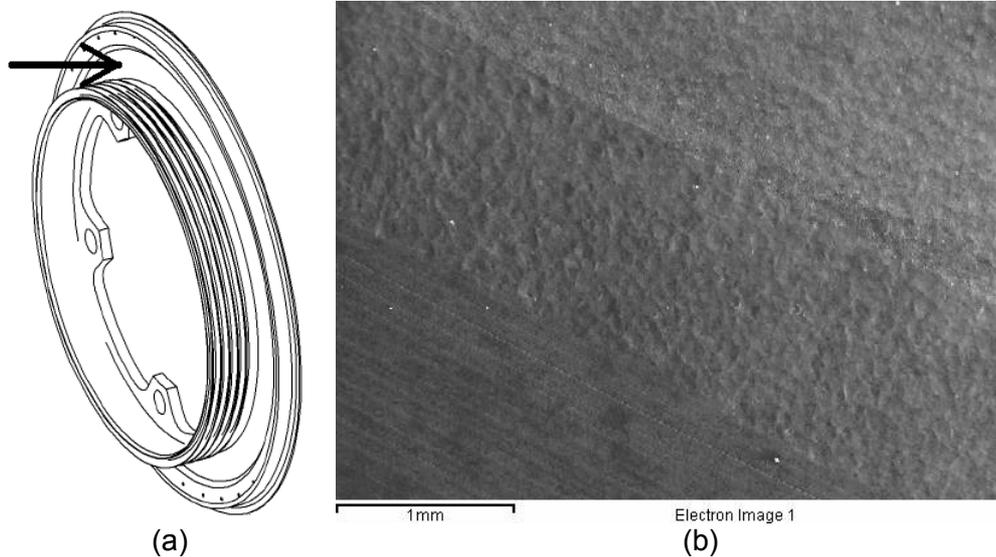
Detailed examination of the specimens revealed the existence of worn surfaces on the plate's coating. More specifically, three different zones of non-uniform wear of the coating were identified on the flange of the plate as shown in figure 7.

FIGURE 7. (a) Observation of the flange. (b) Existence of three different zones of non-uniform wear of the coating.

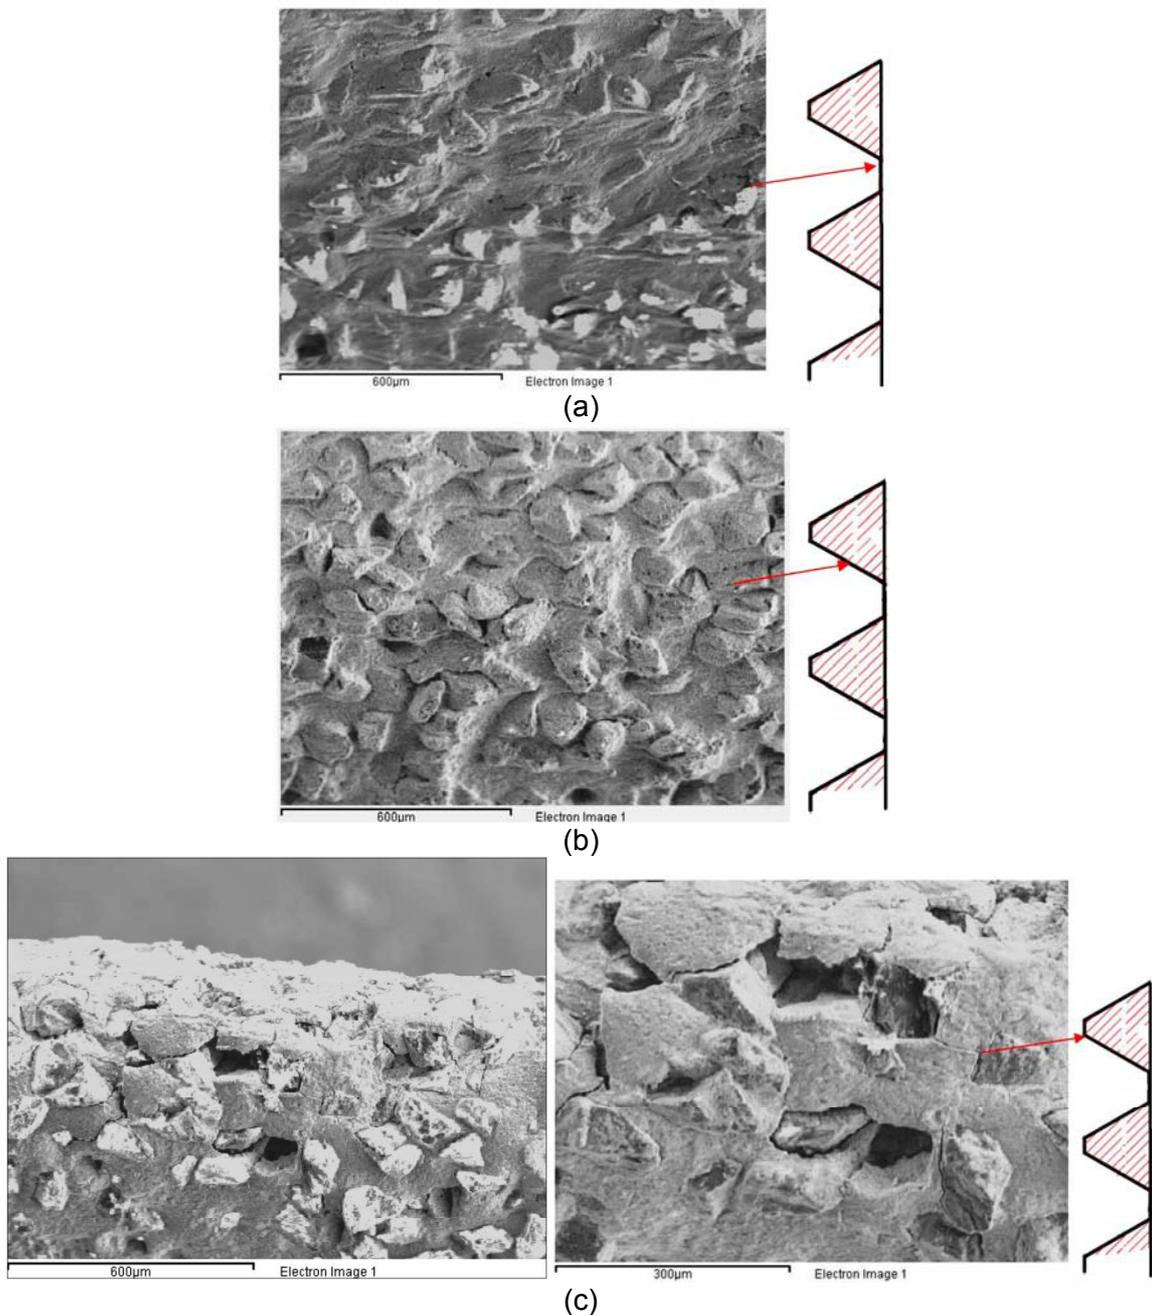
Non uniform wear and extensive cracking was identified on the thread of the plate. More specifically, at the bottom of the thread, which is less exposed to the gasses, good coherence between the coating's matrix and the reinforcing grains was identified. Furthermore no signs of wear or cracking were existent on the coated surface. On the other hand, at the tip of the thread that is more exposed to the surrounding environment, extensive cracking, erosive wear and grain removal from the coating's matrix were identified. The results are depicted in figure 9.

FIGURE 9. (a) Almost intact coating at the bottom of the thread. (b) The intermediate area of the thread presenting erosive wear, partial cracking and partial grain removal. (c) Tip of the thread presenting extensive cracking, erosive wear and grain removal from the coating's matrix.

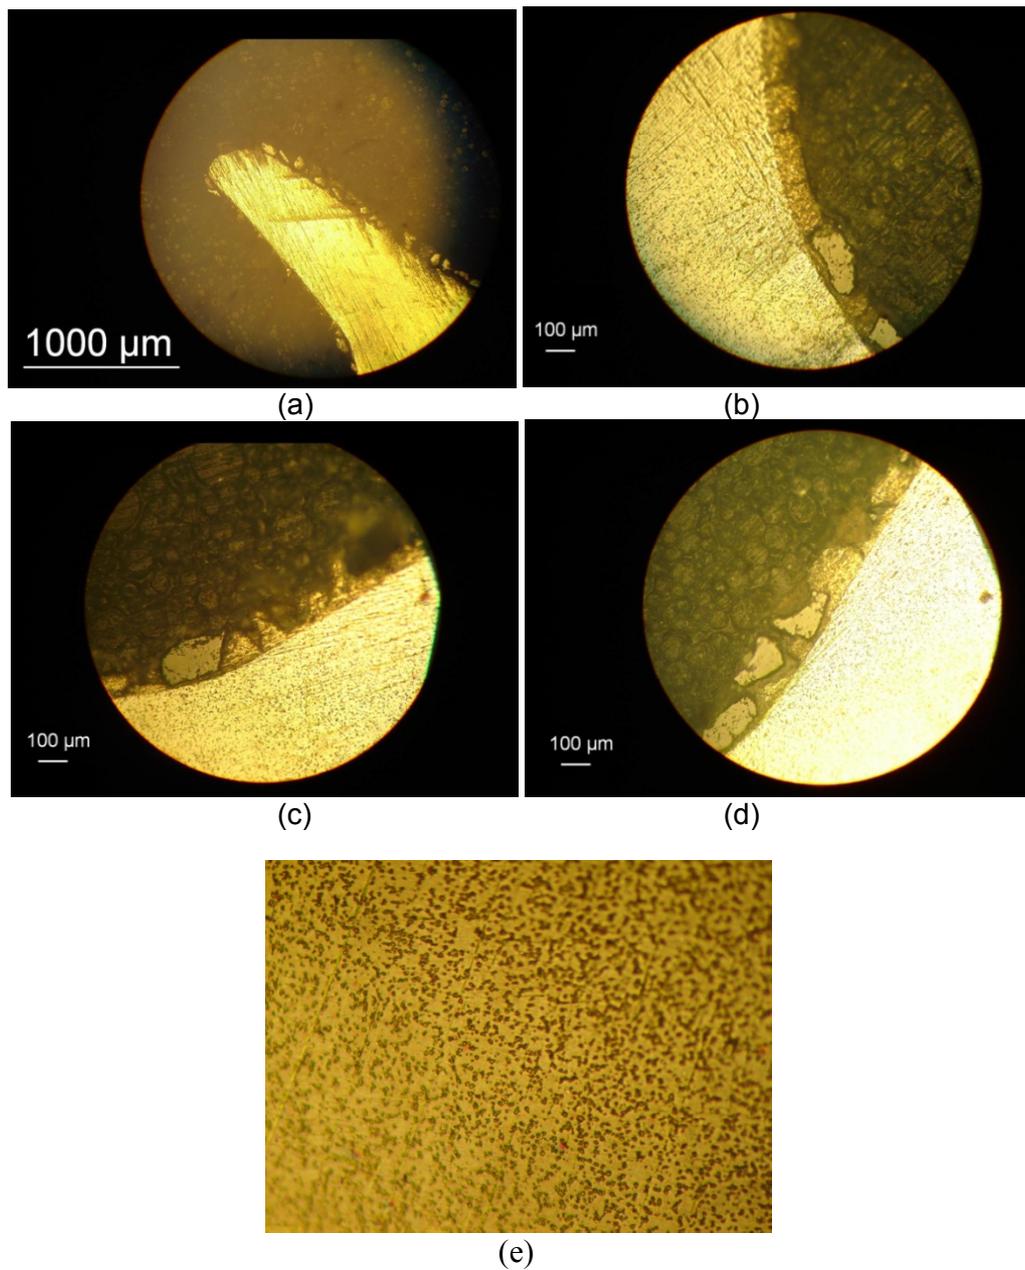
Specimens for microstructural analysis were prepared from a cross section of the thread of the plate in order to investigate whether the identified cracks of the coating (depicted in figure 9) have penetrated the substrate material. The investigation did not identify any cracks propagating through the substrate nickel superalloy. Strongly eroded coating and removal of the reinforcing grains from the coating's matrix were identified. The maximum thickness of the coating was measured equal to 110 μm whereas the minimum thickness was 20 μm at some locations. The analysis also revealed that the microstructure of the nickel matrix contained resolved precipitates. No blocky carbides were identified. The hardness of the plate was measured equal to 73 HRA (450 HV). The microstructural analysis results are depicted in figure 11.

FIGURE 11. (a) Part of the thread with the worn coating. (b) Almost intact coating. (c)-(d) Coating showing grain removal and erosive wear. No cracks penetrating the substrate material were identified. (e) Microstructure of the substrate containing resolved precipitates (x250).

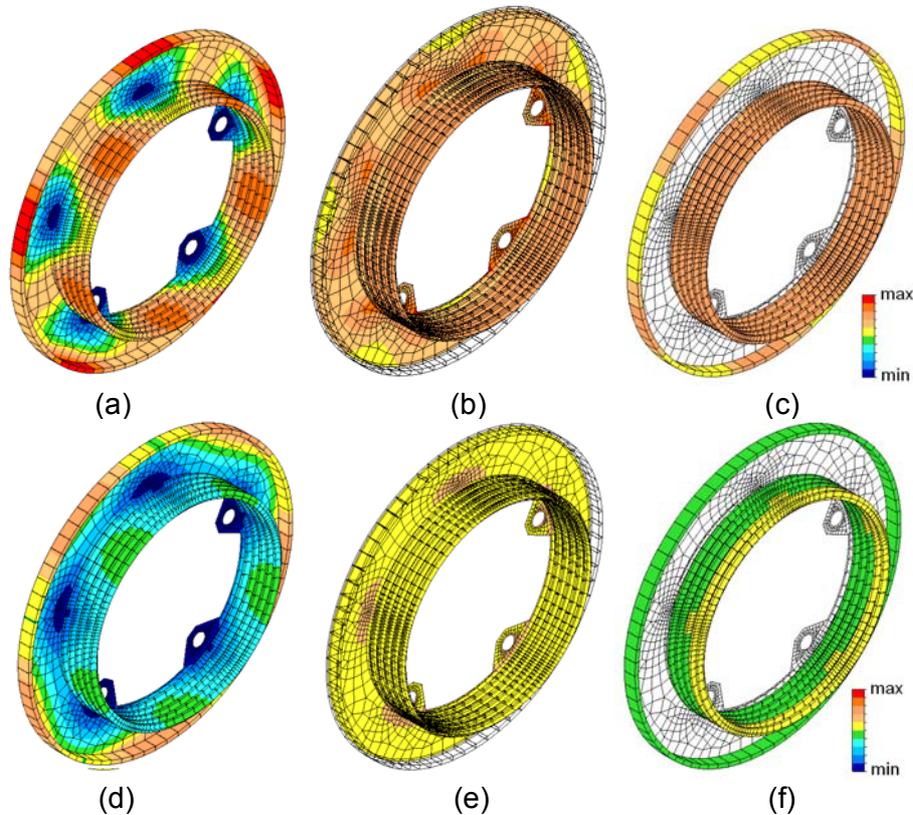
In order to identify the critical locations with respect to maximum stress a three dimensional linear thermo-mechanical finite element model of the most strained plate (stage 1 forward cooling plate) was set up using ALGOR® commercial code. The model contained in total 3163 flat shells (plates) and beam elements that were used to model the thread. The model was assigned with the mechanical properties of a typical Ni annealed alloy (density 8.22 gr/cm^3 , modulus of elasticity 207 GPa, Poisson ratio 0.31, thermal coefficient of expansion $13.1 \times 10^{-6} \text{K}^{-1}$ and shear modulus of elasticity 76 GPa). Coating, gas pressure, friction, rabbit loads, bolt clamp loads and manufacturing process were not included in the analysis. The nodes of the model at the holes of the flange where fixation with the disk takes place were totally fixed. The stress free reference temperature of the model was set equal to 298 K (25 °C). Two different load cases were analyzed. In load case 1 (LC1), the centrifugal loads due to rotation at nominal speed of 44700 RPM were taken into account whereas thermal strains were totally ignored. In load case 2 (LC2), the uniform temperature of the plate was set equal +100 K above the stress free reference temperature in order to let the thermal strains develop on the model, whereas the centrifugal loads were not accounted for in the analysis. The results of the FE analysis are shown in figure 12. The common 10-color contour legend refers to maximum and minimum displacement or stress: the maximum displacement of the legend refers to 0.2 mm whereas the minimum to 0 mm. The maximum stress of the legend refers to 1158 MPa whereas the minimum to -1158 MPa.

Here it has to be emphasized, that in real world the forward cooling plate, the rotor disk and the aft cooling plate although being fixed together, are allowed to expand due to temperature increase at bigger degree compared to the case simulated previously (total fixation); thus the thermal stress results presented in figure 12 represent a conservative solution. From the FEA results it is deduced that the critical sites for optical observation are located at the vicinity of holes of the flange where the fixations with the bolts exist, at the intersection of the flange and the thread and the thread as well. Notice, that the FEA results presented herein provide only a

FIGURE 12. (a) LC1: Magnitude of displacements due to rotation. (b) LC1: Von Mises centrifugal stress on flat shells. (c) LC1: Worst centrifugal stress on beams. (d) LC2: Magnitude of displacements due to temperature increase. (e) LC2: Von Mises thermal stress on flat shells. (f) LC1: Worst thermal stress on beams.
