Forensic engineering methodology to assess the Maintenance, Repair and Overhaul (MRO) procedures for Gas Generator Turbine Cooling Plates

Abstract. Investigation was carried out on a set of cooling plates obtained from a gas generator turbine (GGT). The need for the assessment of the durability and remaining operational life of the gas generator turbine component was identified, following a recommendation by the manufacturer for the early replacement of the cooling plates. The current study applied a forensic engineering and failure analysis methodology to assess the Maintenance, Repair and Overhaul (MRO) procedures of high reliability components. From the results of the current investigation it was finally deduced that, in spite the fact that the plates seemed to be macroscopically in good condition, certain metallurgical observations sustained the claim for early component replacement.

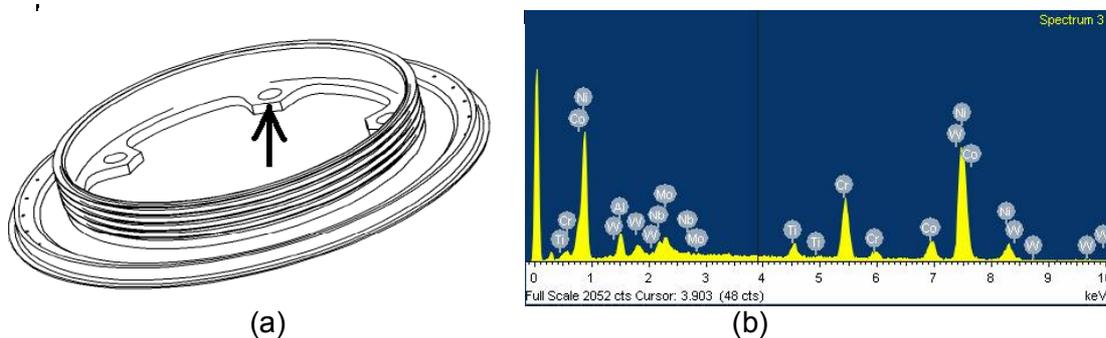
In order to further examine the plates for potential cracks and wear, Scanning Electron Microscopy was used. For this reason specimens from the most strained plate (stage 1 forward cooling plate) were prepared. Chemical analysis of a cross section of the flange (coating excluded) using SEM/EDS presented the chemical composition shown in table 1 and figure 6b.

FIGURE 6. (a) Specimen location for the SEM/EDS chemical analysis. (b) Results of SEM/EDS chemical analysis

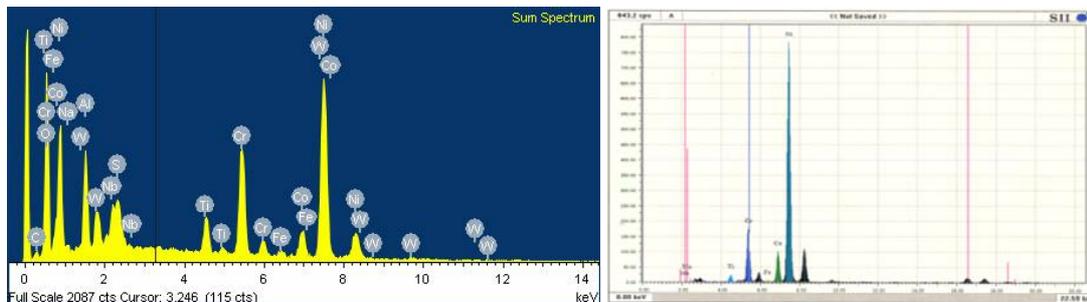
Qualitative local chemical analysis of the worn coated surface using both SEM/EDS and XRF revealed the existence of the elements shown in Table 1 plus some small amounts of Fe as shown in figure 8.

FIGURE 8. Local qualitative chemical analysis of worn coating (a) SEM/EDS results. (b) XRF results

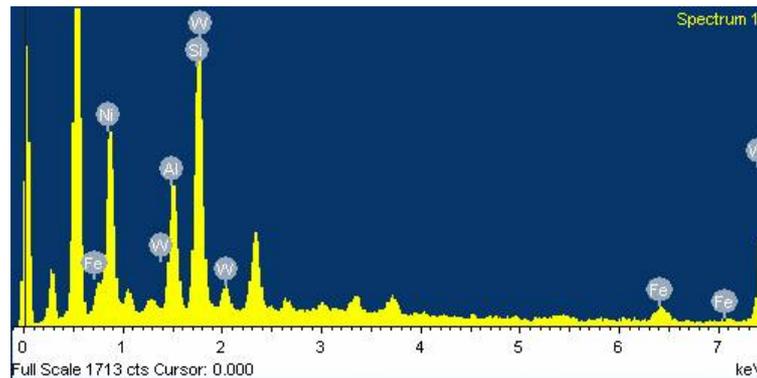
The SEM/EDS chemical analysis results of the coating at the worn tip of the thread are presented in Table 2 and figure 10. No cracking was identified at any other location of the plate.

Element	Al	W	Si	Fe	Ni
%w/w	11	7	23	2	bal

FIGURE 10. Local chemical analysis results by SEM/EDS of the worn coating at the tip of the thread
